POST INCIDENT ANALYSIS

936 VEIRS MILL ROAD

JUNE 6, 2012

BC DOUG HANSON BC 703

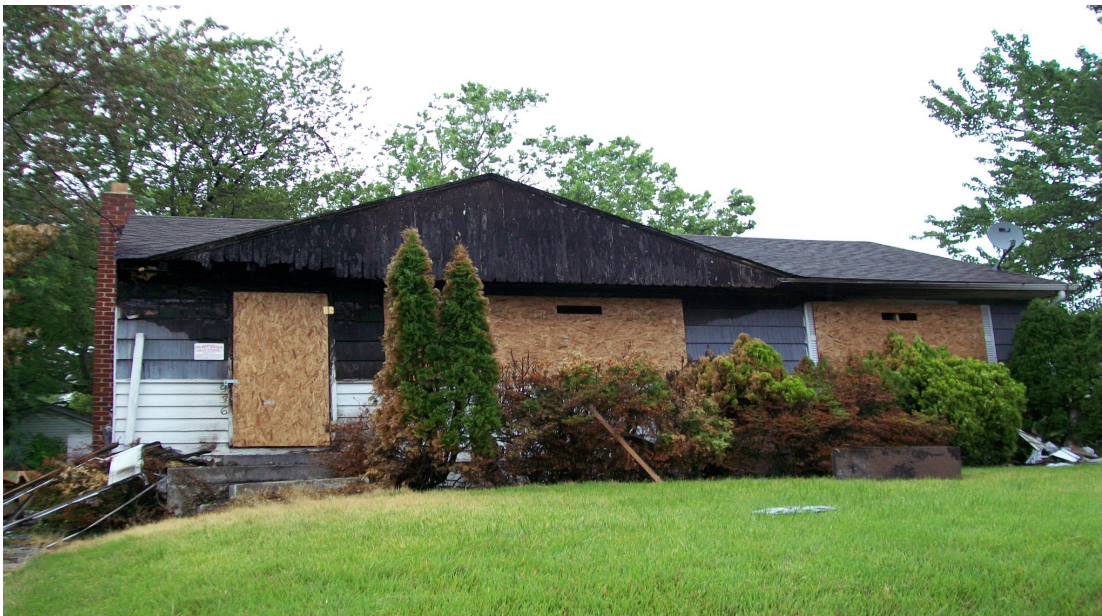
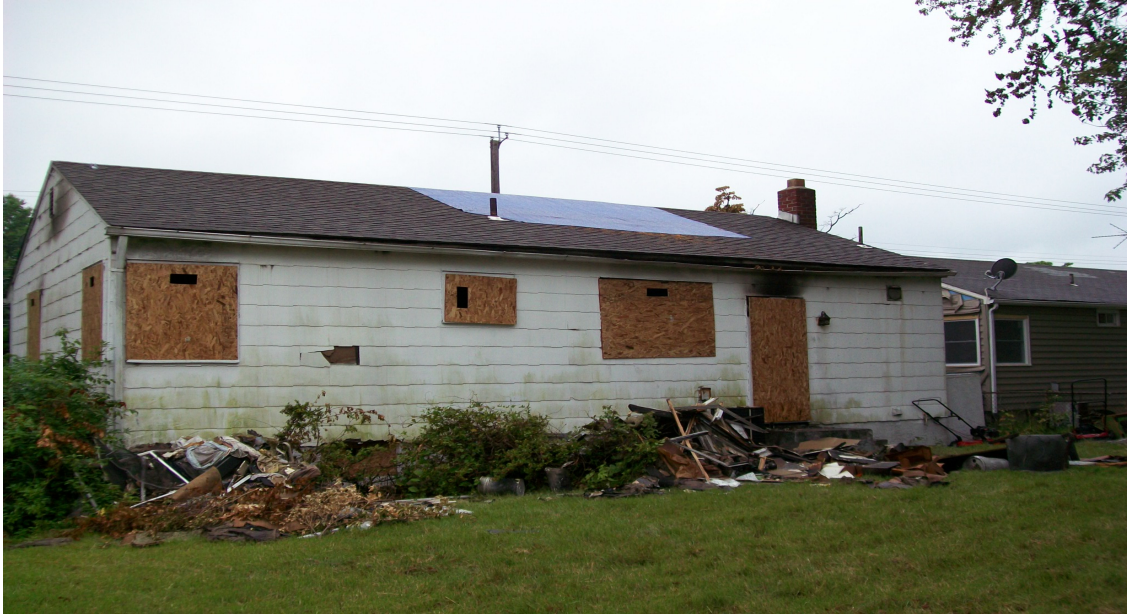
The Building: The house is described as a single story single family occupancy of wood frame construction. The house was built in 1952 and has 864 square feet of living space. The exterior was wood clap board, the walls and ceilings were constructed of drywall. The roof had asphalt singles and an approximate 4/12 pitch to the roof. The house was positioned on the corner of Woodburn Road and the service road of Veirs Mill.
